Dunston Staiths, Gateshead: Repair of one of Europe's largest wooden structures

Charles Blackett-Ord
Blackett-Ord Conservation Engineering
Cumbria, United Kingdom

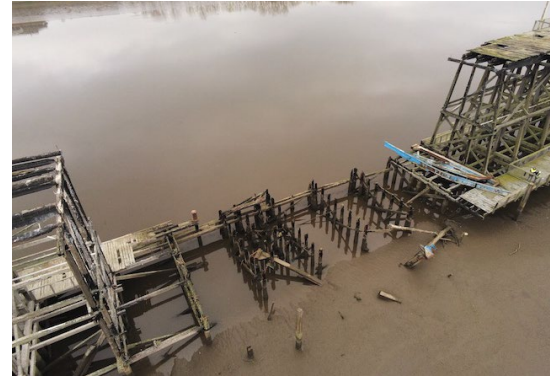
Figure 6: Fire Damage (2003)

In 2003 a large section was damaged by fire, and ten frames were completely destroyed only leaving the exposed pile heads. This meant that there was no access along the structure from one end to the other.

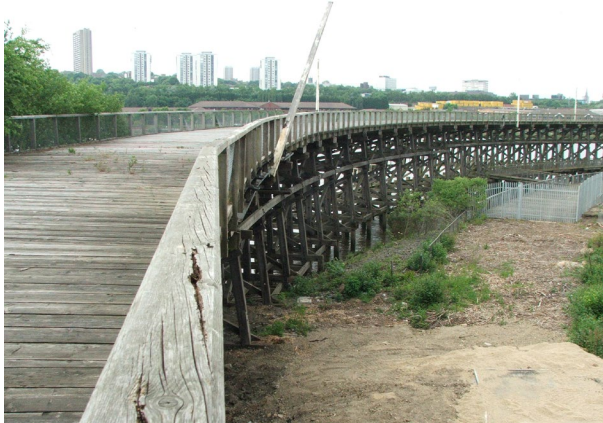
Figure 7: Land Based Frames

It was accepted at an early stage that it would be impossible to fund repairs to the whole structure, so of the 98 frames only frames 1 – 8 which are land based, and frames 32 – 39 which are near to the stairway put in for the Garden Festival, would be repaired at this time. The areas selected for repair were those that had been damaged by fire and timber decay and included the lower parts of the frame posts at the land end, and the main deck beams and frame cross heads of frames 32 – 39.

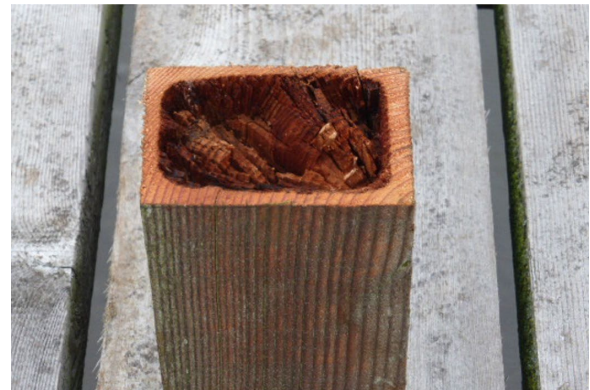
Figure 8: Fence Post Decay

It soon became apparent that timbers that looked sound externally could have very considerable internal decay. In some cases this resulted from the previous preservative treatment only penetrating a few millimetres, and rot setting in from exposed end grain. This was particularly evident in the balustrading fence posts and handrailing which were Douglas Fir, and which, away from end grain exposure, were perfectly sound. The rot in the main deck beams started from the top, where the 20mm gap between the deck planks allowed water to sit.

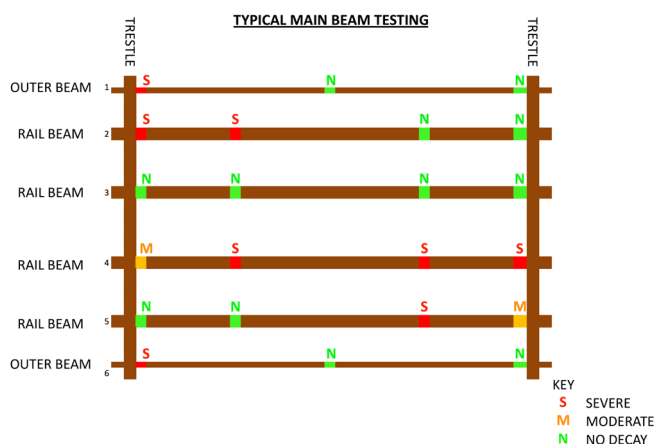
Figure 9: Main Beam Testing (Credit: BM Trada)

BM TRADA's condition survey with a micro-drill tested the main deck support beams by drilling down from deck level (there being no access below). The main deck beams comprised two 305 x 305 beams on top of each other, and an extended drill bit allowed the lower one to be tested also. They tested 206 upper deck beams in 752 locations (ends and centres), and severe decay was noted in 17% of these locations, and in 36% of the beams.

The lower beams were tested in 100 locations and this revealed that there were 14 results where the upper and lower beams had severe decay in the same locations (in the centre or at the ends). In some locations there was severe decay on the lower beams where the upper beams were sound. As only one beam is required for current loading requirements a rotten lower beam was not of concern structurally as long as its ends were sound, where it provides bearing support to the upper beam.

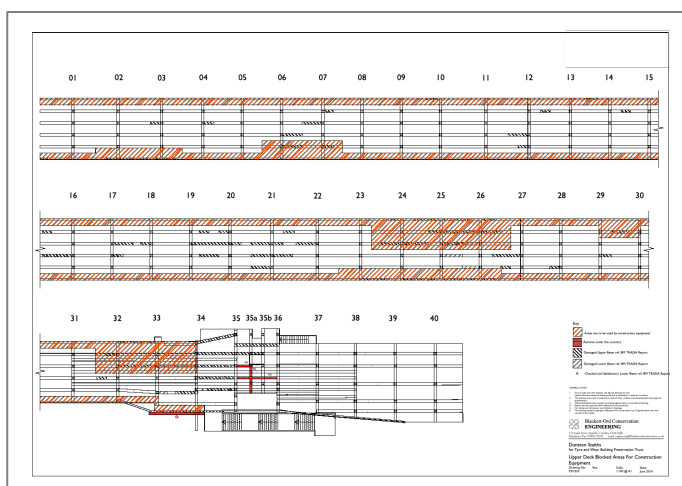
Figure 10: Upper Deck Safe Access

Following this testing it was found to be possible to fence off areas of doubtful strength so that construction traffic could be confined to the less severely decayed areas. Timber decay can be very localised, particularly at the bearing ends of beams where there may be exposed end grain, and the micro-drilling of necessity had to be selective. With timber of this size up to half a dozen drillings may be needed for complete satisfaction that there is sufficient sound timber remaining in any one location. In fact in spite of several visual inspections and the micro-drilling, one of the crosshead beam ends failed unexpectedly under its own weight during the course of the repair contract.

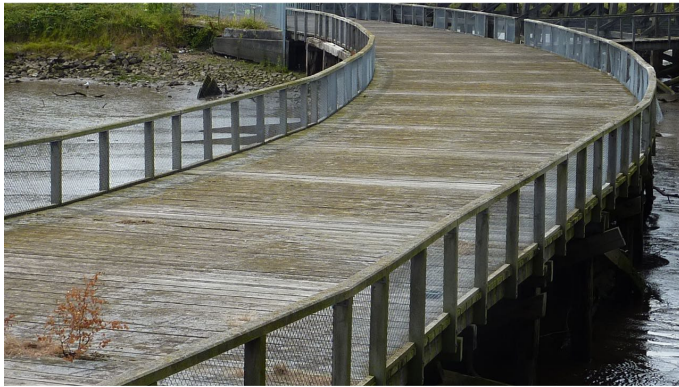
Figure 11: Lower Deck Lichen Growth

One curious observation is the variation of lichen growth on the deck planks. The colouring clearly shows the presence of the support structure beneath, showing that tiny changes in air movement can have an environmental effect on the timber.

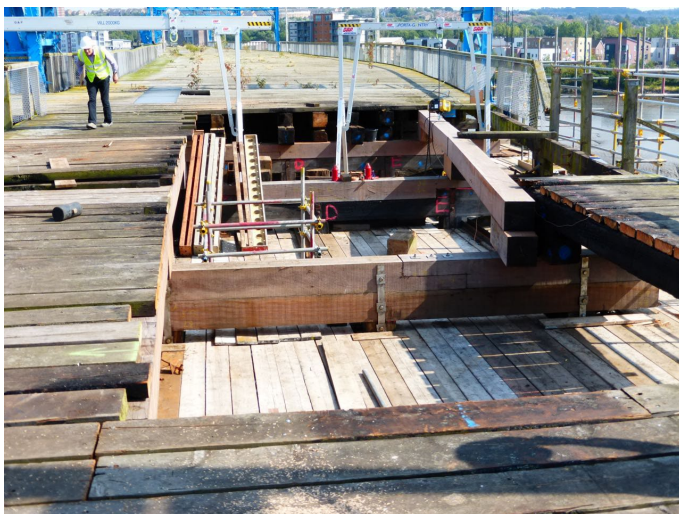
Figure 12: Upper Deck Repairs (2015)

Where possible the deck beams were replaced as whole beams, spanning between the frames. This necessitated taking up the deck to gain access. The lower beams were not replaced as whole units, but only where needed in short lengths to support the upper beams over the trestles. The crosshead repairs did not usually need whole beam replacement and so halved joints were used between the old and the new, as was the case with the vertical posts, and these were bolted with stainless steel bolts. Diagonal bracings were repaired using scarf joints.

A significant number of repairs were required where the frame cross bracing was fixed to the frame posts, where corrosion of the bolts had split the timber. In most cases the old bolts could be removed and replaced with stainless steel, with a secondary cross bolt to close the split. Where it was not possible to remove the old bolt new ones were inserted close by. Where it was not possible to insert the secondary bolt, where access for drilling was impeded by other members, large toothed timber connectors were used under the plate washers to help hold the split together. Where corroded bolts were left in-situ there remained a risk of future corrosive expansion, and hence more splitting of the timber, but for the medium term this was prevented by the cross-bolting.

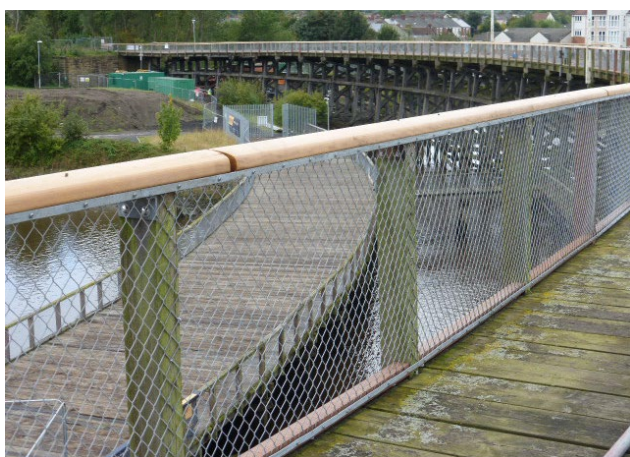
Figure 13: New Handrailing

Handrailing was re-detailed so that the top rail joints are not over the posts, and the bottom rail did not sit on the deck planks as before. This not only prevented water retention, but it allowed individual planks to be replaced without removing the handrailing.
