THE TRETTEEN BRIDGE COLLAPSE. How could it happen?

Kjell Arne Malo
Department of Structural Engineering,
NTNU Norwegian University of Science and Technology
Trondheim, Norway

The Norwegian Safety Investigation Authority (NSIA), together with an external expert group, have carried out the technical investigations with respect to the collapse. The investigation is documented by the report [2]. The present author was a member of the external expert group.

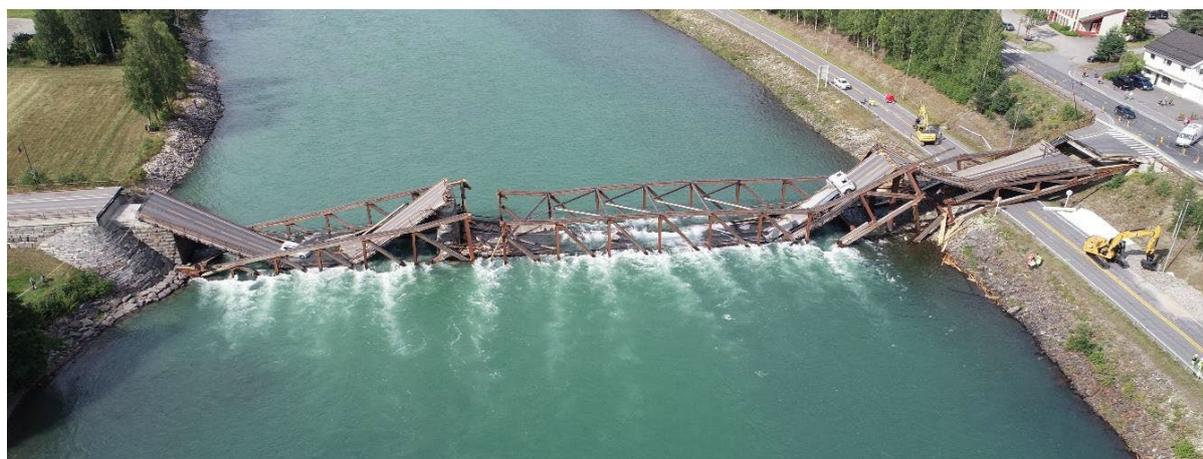
Not only one of the main river crossings was lost, also the European highway (E6) which is the main route to north and north-western parts of Norway, was blocked and the traffic had to be redirected through narrow roads in residential areas at Tretten. The bridge collapsed without warning, for traffic loads much smaller than the design load. Luckily no-one was seriously injured, both drivers on the bridge at the collapse were safely rescued.

Figure 2: Bridge after collapse

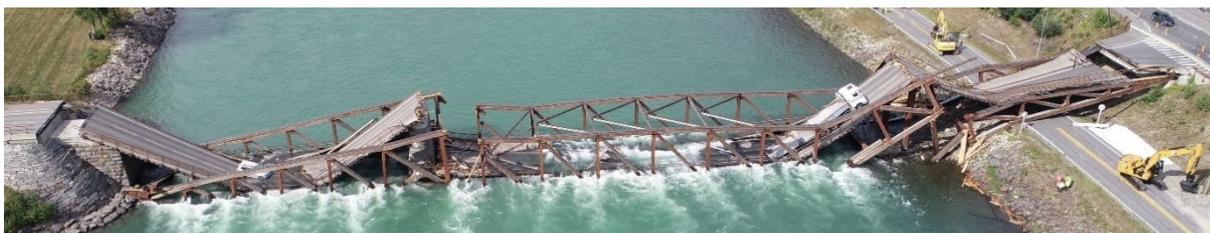
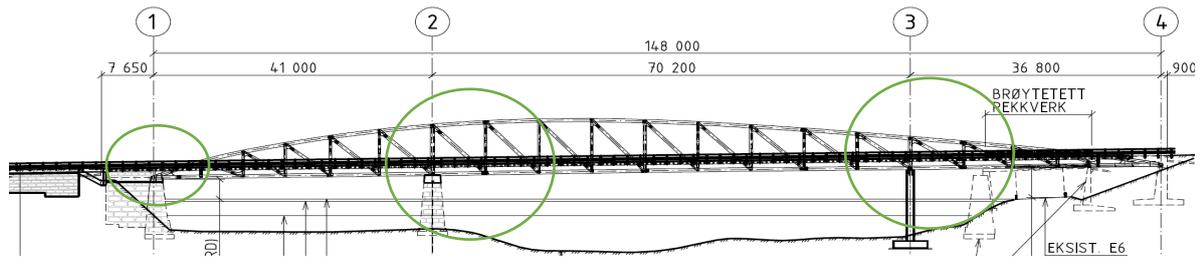
Figure 4: bridge and bridge zones with top priority (marked with circles)

As it may be observed from photo on Figure 4, the U-frame at axis 3 has lost its integrity and the connected trusses have fallen off the supporting crossbeam. This possible failure scenario requires that the bolts securing the vertical steel member to the steel crossbeam fail. An initial failure in this connection requires hence an axial force in the bolts, either causing a tensile failure in the bolts or fatigue failure due to cyclic moments. All bolts had fallen off and therefore the first rescue operation at the bridge site was to use large electromagnetic devices to collect all possible metal parts which had ended in the river due to the collapse. In this way almost half of the bolts were found and based on the fracture zones, it was clear that all bolts were clipped off, and no trace of axial or fatigue failure was seen. It was therefore concluded that the support in axes 3 was not the initial failure location.

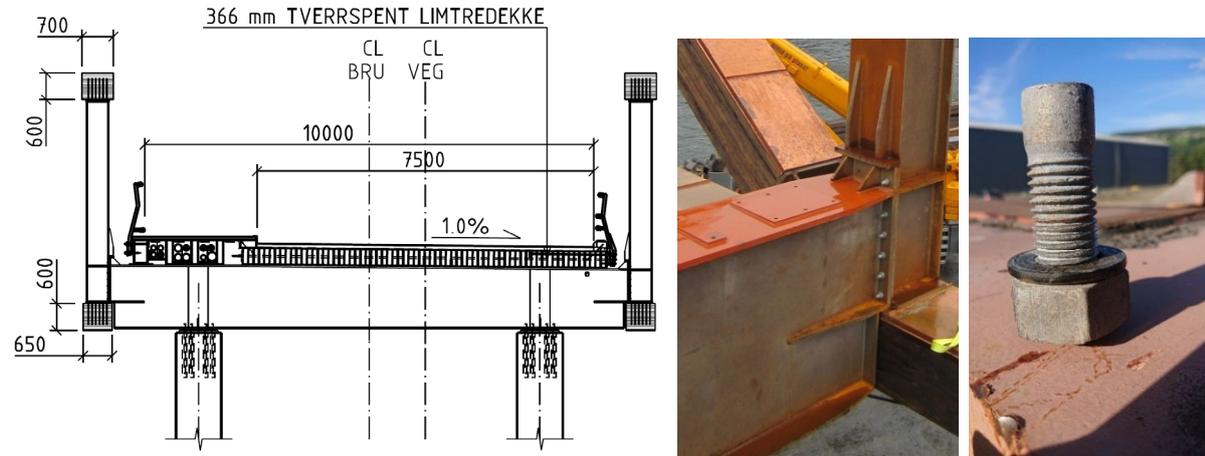
A drawing of the U-frame in steel is shown on Figure 5. The vertical forces are transferred directly through brackets, while moments engage the bolts in the connections.

Figure 5: Left: U-frame in steel at axis 3 Right: Moment rigid connection in U-frame. Clipped bolt

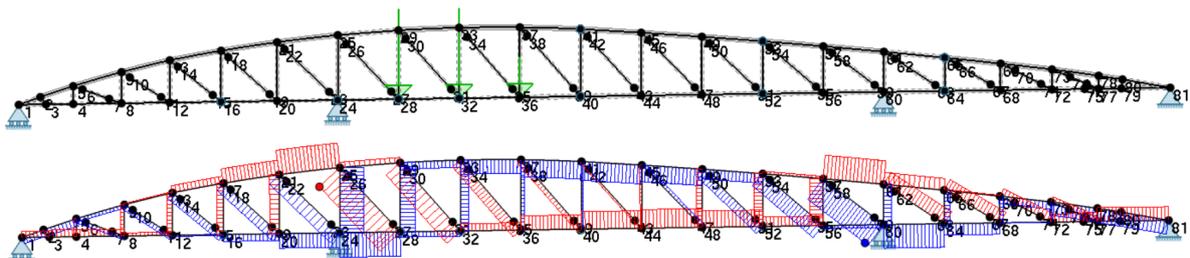
The bridge was modelled with different levels of detailing using several 3D programs in addition to a 2D program. As the behaviour of the bridge is almost symmetrical about the longitudinal centreline of the bridge, and the collapse mode also appears symmetrical, the results from 3D and 2D programs were very close. Figure 6 presents the basic modelling approach together with the axial force distribution due to the lorry on the bridge at the collapse in critical position. The lorry model was lorry no 3 in fatigue load model 4 (FLM4) in EN 1991-2, as it was quite similar in weight and load distribution. The resulting axial force distribution indicates that the most utilized zones are close to axes 2 and 3.

Figure 6: Numerical simulation of the loading immediately prior to collapse Upper: Vehicle on critical location for zone around axes 2 Lower: Axial force distribution, resulting critical zones close to axes 2 and 3

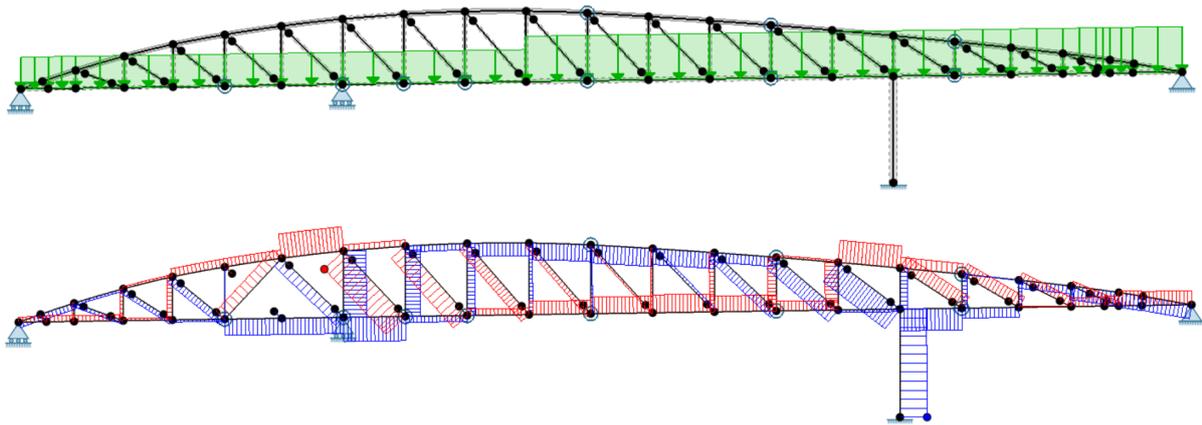
It was discovered that the deck structure (continuous stress laminated timber deck) and the support columns at axis 3 had a significant role in the collapse, so the structural FE models were altered to accommodate for a more realistic behaviour when large deformations occur in the simulations. The left part of the truss between axes 1 and 2 behaves like a rigid body during the collapse (see photo on Figure 4) and the force distribution within this part becomes insignificant. The lower chord here was replaced by the deck structure, and the deck was allowed to detach from the line of the lower chord. The roller support at axis 3 was replaced by a steel column fixed to the joint in axis 3. The self-weight and traffic load on the structure were kept constant. The modified static FE model and the resulting force distribution in undamaged state are shown in Figure 7.

Figure 7: Modified FE model for progressive collapse

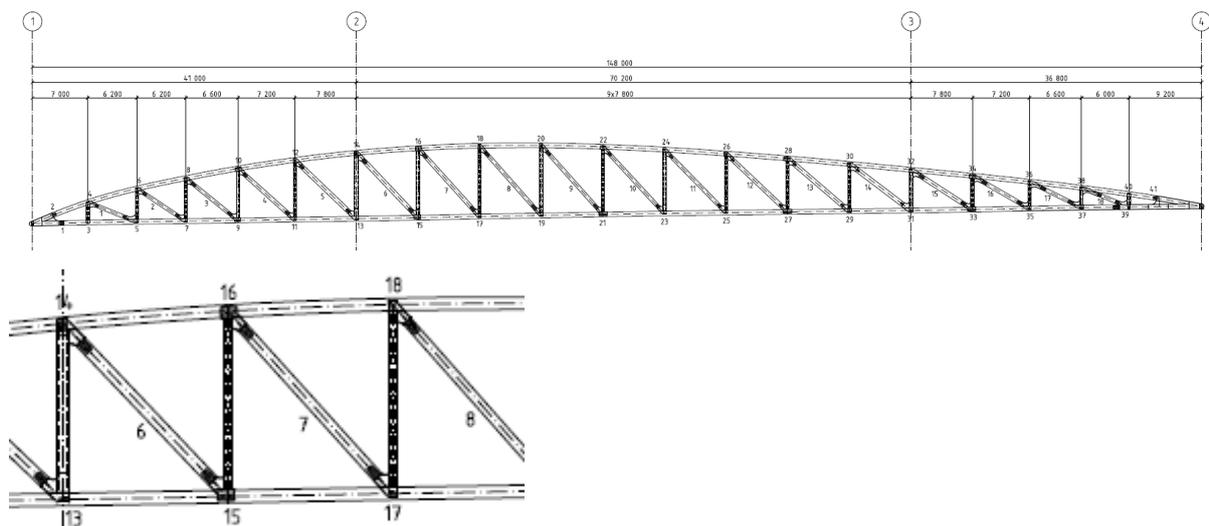
Several initial locations were explored, but it turned out that only failure initiation in diagonals 6 or 7 were consistent with the observed damages from the collapse, and had the potential to propagate the failure into a full collapse for the given load scenario with a single lorry of 490 kN on the bridge. However, an initial failure in diagonal 7 did not give immediate failure propagation, but merely additional damage to the neighbouring elements like diagonal 6. When a failure in diagonal 6 occurs, the failure will propagate. The potential elements for failure initiation are visualized on Figure 8.

Figure 8: Potential elements for initial failure, diagonal 6 and 7

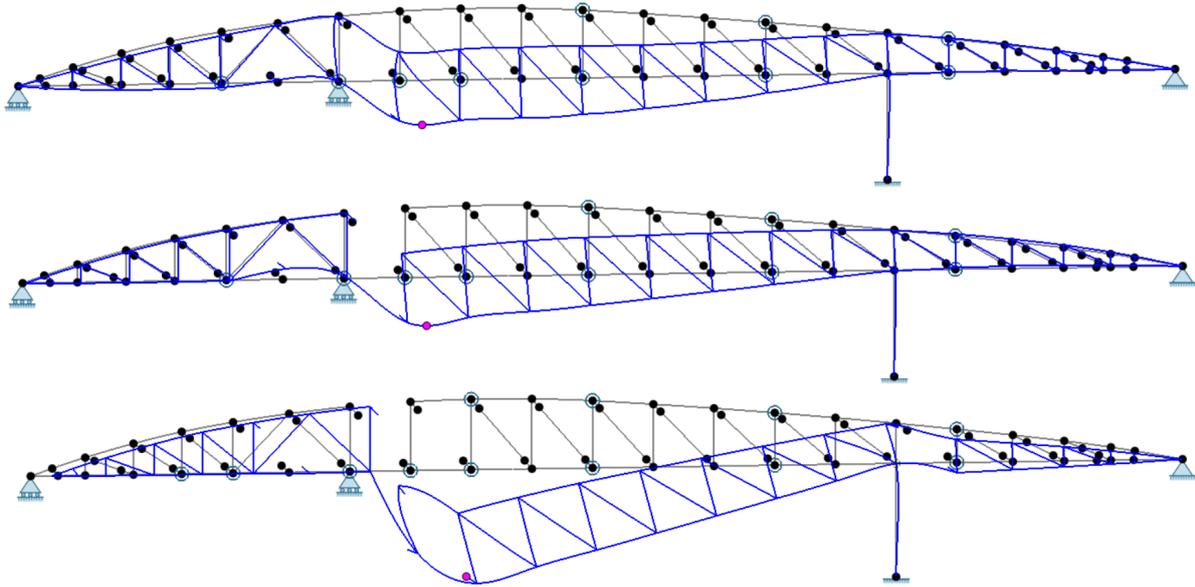
Figure 9: Progressive collapse after initiation in diagonals 6 or 7

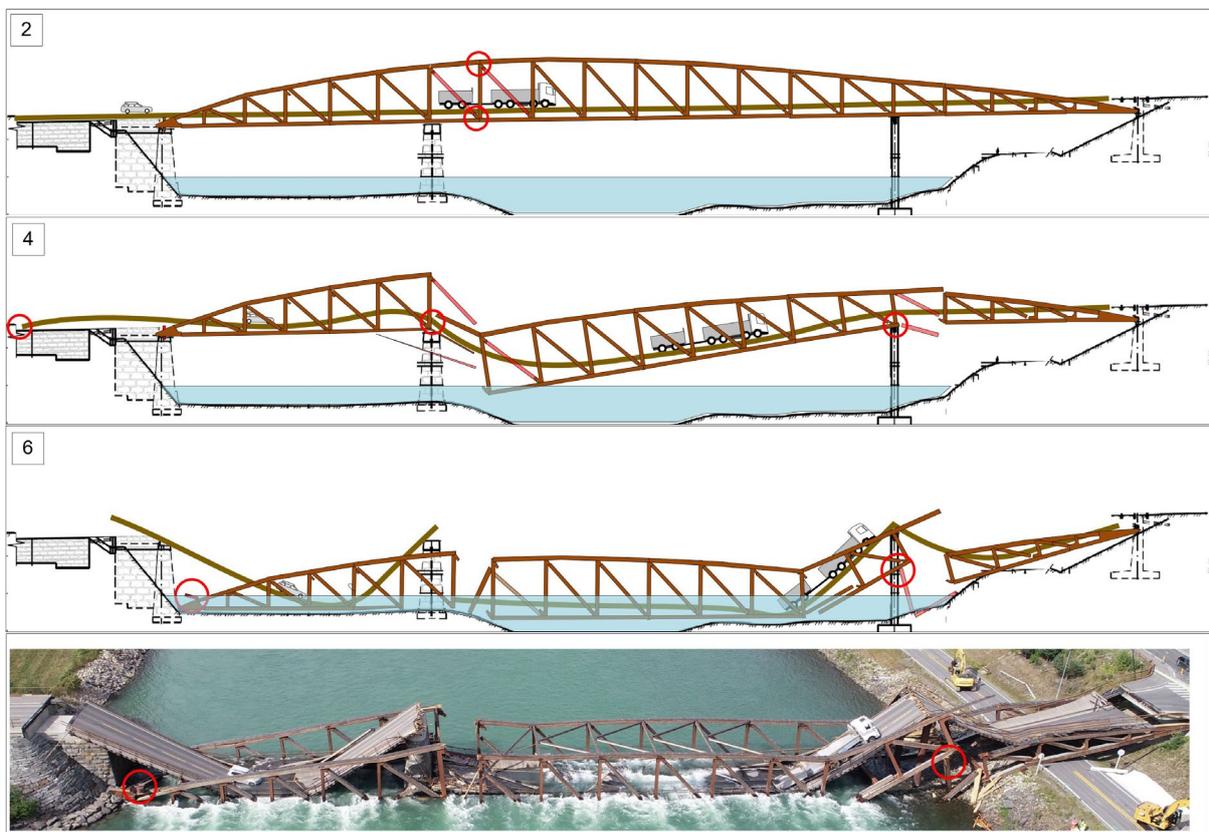
- The failure is initiated in diagonals 6 or 7.
- Left part axes 1-2 moves like a rigid body, the deck acts as a membran and pulls off the cross beams from the supports at axes 1 and 2.
- The splice and diagonals to the right of axis 3 become overloaded.
- The bolts at the crossbeam in the U-frame in axis 3 are clipped by the rotational movement of the center part of the bridge and trusses fall.

Figure 10: Visualization of the stages of progressive collapse

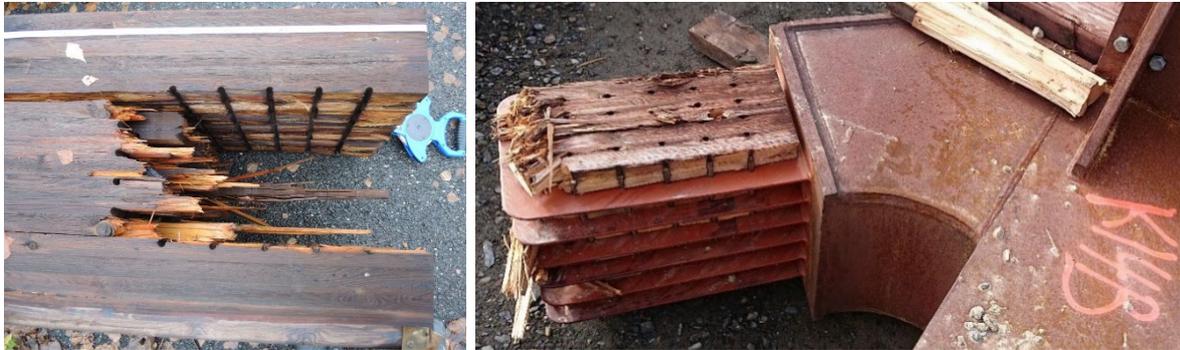
The diagonals 6A, 6B, 7A and 7B all had large tensile forces (A = upstream truss, B=down-stream truss). The moments at the joints of the trusses were not large but might have effect on the strength of the connections. During the progressive collapse the moments in some joints became large and led to moment failure. Most of the failed joints in diagonals 6A, 6B, 7A and 7B showed variants of block (shear) pull-out failure, consider Figure 11.

Figure 11: Block (shear) pull-out failure joint 14B in diagonal 6B

The fatigue computations considered all failure modes in the connections and most of the connections showed no vulnerability to fatigue damage. However, some of the connections were extremely exposed to fatigue damage, especially the connection in diagonal 7, which has passed its lifetime to an extreme degree with a Miner-Palmgren sum of more than 200. The next connection is the one in diagonal 6 with Miner-Palmgren sum more than 9, hence this diagonal was also well above its expected lifetime. Also, connections in diagonal 16 close to axis 3 showed too much fatigue damage. The fatigue damage were all due to tensile block (shear) pull-out failure mode.

Tretten bridge had reduced strength prior to the collapse. There was no trace of traffic overload and the most likely cause of the collapse is damage accumulated over time i.e. fatigue. The failure mode was block (shear) pull-out failure. The bridge was designed according to regulations [7] from the national road authorities and the Norwegian national standard for timber structures at that time (NS 3470-1) [8], which did not have any regulations regarding block (shear) pull-out failure. Diagonal 7 was much more exposed to fatigue than diagonal 6, and most probably failure initiation took place in diagonal 7. However, also a failure in diagonal 6 was necessary for propagation. Wood has large variability in strength, and by assuming that diagonal 7 is 20% stronger than diagonal 6, the order of failure initiation may be switched between diagonals 6 and 7. The fatigue is caused by too high stress concentrations in the head tensile area resulting from narrow dowel groups.

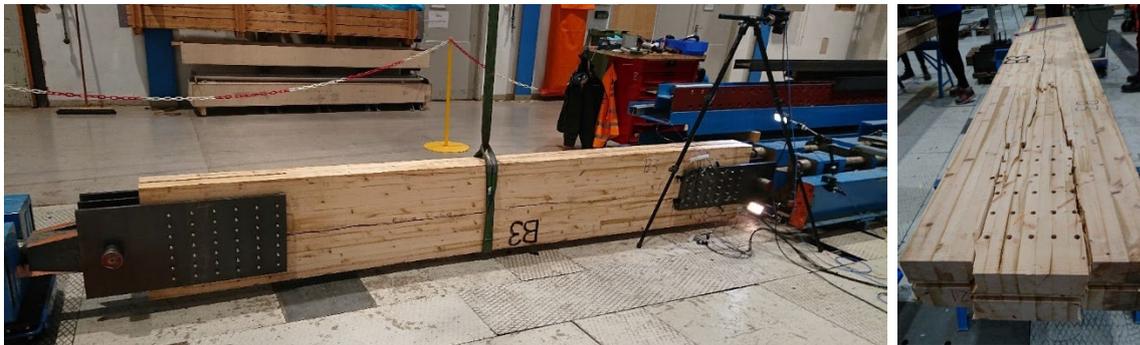
Figure 12: Connection test leading to block pull-out failure

The tests confirmed that block (shear) pull-out was the lowest failure mode, and that the small head tensile area was critical together with the tensile strength. The evaluation of the mean tensile strength gave the following:
