Dunston Staiths, Gateshead: Repair of one of Europe's largest wooden structures

Charles Blackett-Ord
Blackett-Ord Conservation Engineering
Cumbria, United Kingdom

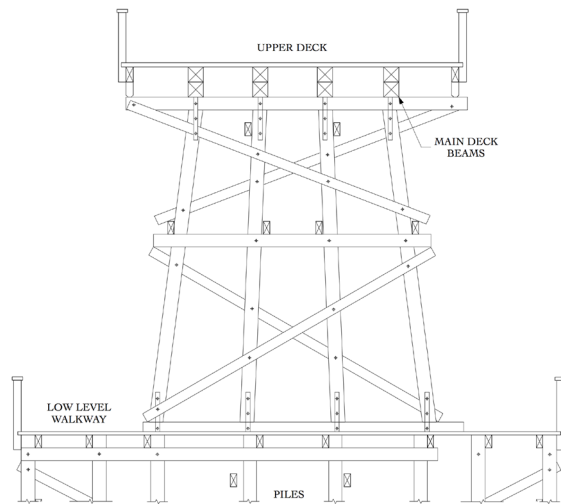
Figure 4: Typical Support Frame

The Staiths comprise a simple structural framework of 98 trestle frames on timber piles at 5.3 metre centres, supporting a timber deck spanning between the frames, with a width varying between 8 and 12 metres. There are additional intermediate frames to carry six steel discharge gantries and hoppers.

are composed of four or more vertical or inclined posts 305mm x 305mm in section on 325mm x 325mm timber piles. The main cross heads at deck level and the main longitudinal sections are two layers of 305mm x 305mm timber, and the secondary edge beams, bracings etc. are 305mm x 150mm or 225mm x 150mm. The deck was originally 305mm x 75mm thick planks, nailed to the longitudinal beams. The piles are greenheart or pitch pine and the original superstructure Baltic pine and Pitch pine, but repairs were generally carried out in Douglas Fir, pressure creosoted.

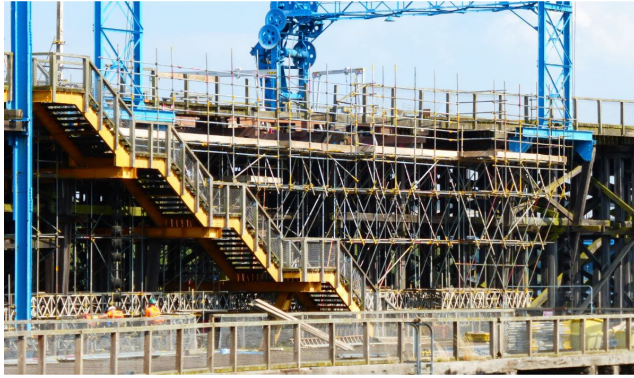
Figure 5: Garden Festival Staircase

The central part of the South Staiths was removed, including the piles, leaving the two ends which were decked out at low level. Two flights of access stairs were provided up to the top deck and all the remaining structure was repaired. The percentage of single cross-heads that had failed was 30%, and 60% of the outside cantilevered deck bearers had failed. The deck was renewed entirely, and the repairs were completed in 1988 at a cost of around £1.2m. (1.5m Euros). So we have these works as a datum for measuring subsequent decay.
